# Appendix G

**Site Inspection Checklist**

# Five-Year Review Site Inspection Checklist Rocky Flats, Jefferson County, Colorado

#### Attachment 1: March 2017 Monthly Report of the Original Landfill Inspection at the Rocky Flats Site

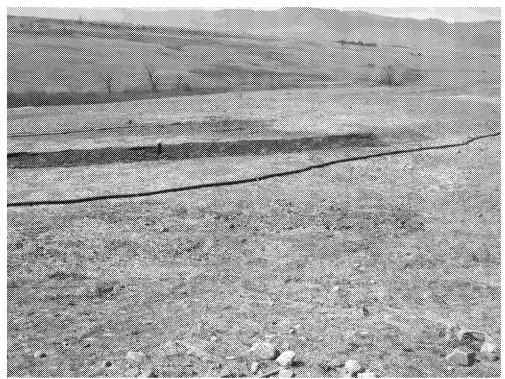
No new signs of movement were observed on the OLF (Figure 2). No new cracks since the time of the previous inspection have been observed. Regions that show cracks that were backfilled are no longer checkmarked on the inspection form. Items that are checkmarked are from previous cracks that cannot be backfilled with hand tools. A description is included with information about the checkmarked items. The most notable cracks in 2016, southeast of Berm 5 starting just below Seep 2/3, were repaired during the September 2016 minor regrading (Figure 3), and since then, no signs of cracking or movement have been observed.

Figure 2. Looking South at Berm 4 and the New Above-Ground Drain Pipe Running from the OLF Groundwater Intercept System to the ESSD

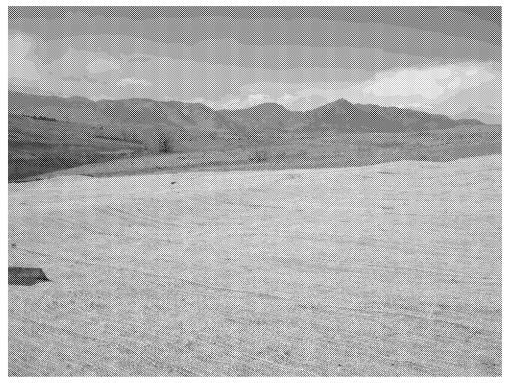
Figure 3. Looking West, Just East of Berm 6

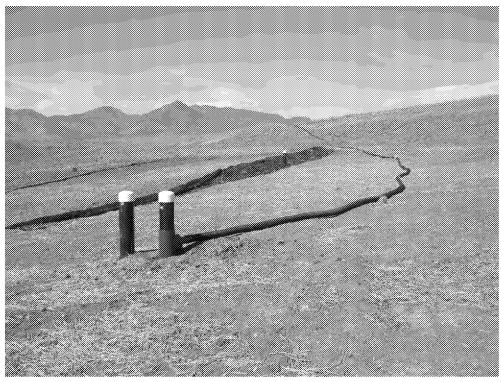
The construction of the OLF temporary groundwater intercept system started on March 14, 2017. At the time of inspection, the gravity drain line was in place and connected to the East Subsurface Drain (ESSD) (Figure 4). During the inspection, a subcontractor was flushing water through the ESSD lines and repairing the erosion control mat near the ESSD that had blown away. Weekly inspection of the ESSD and ESSD outfall has not resulted in the discovery of any visible water flowing out of the pipes; however, the ESSD outfall was damp. Erosion-control is in good condition, and most of the minor damage occurring from wildlife and high winds has been repaired (Figure 5). Staking the drainage pipe at more frequent intervals has reduced movement caused by high winds and is expected to increase the life of the drainage pipe. The revegetation of recently disturbed areas on the OLF is managed and monitored under the *Erosion Control Plan for Rocky Flats Property Central Operable Unit* (DOE 2007)<sup>1</sup> and under the sitewide vegetation and revegetation plans.

Figure 4. Looking West, at Berm 4 and the Gravity Drain Line Connection to the  ${\ensuremath{\sf ESSD}}$

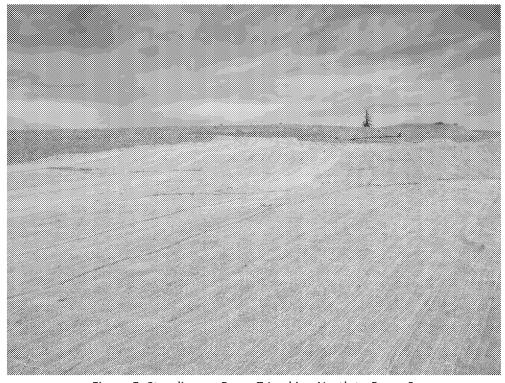
Figure 5. Standing on Berm 7 Looking North to Berm 6

Deficiency	Date noted	Action	Date completed	Comments
Drainage pipe behind Berm 7 was damaged	3/22/17	Drainage pipe was repaired with new coupler and taped	3/22/17	· · · · · · · · · · · · · · · · · · ·
Erosion-control mat disturbed south of berm 7	3/22/17	Restaked erosion control mat, ecologist was notified	3/22/17	
-

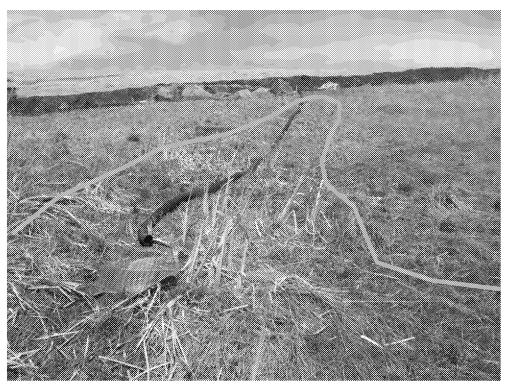
Seep 8A had the highest flow of the seeps at approximately 2 gallons per minute (gpm). Seep 2/3 was flowing less than 1 gpm and Seep 7 was damp. Seep 9 and Seep 4 had pockets of water with no visible flow. A wet area was discovered, about 30 feet north of the Seep 2/3 drainage outfall, flowing at approximately 1 gpm (Figure 6). The wet area appears to be from water in the East Perimeter Channel (EPC) that percolates through the EPC side slope instead of

Figure 6. Standing Below the Seep 2/3 Drainage Outfall Looking North at the Wet Area Discovered (estimated outline in blue)

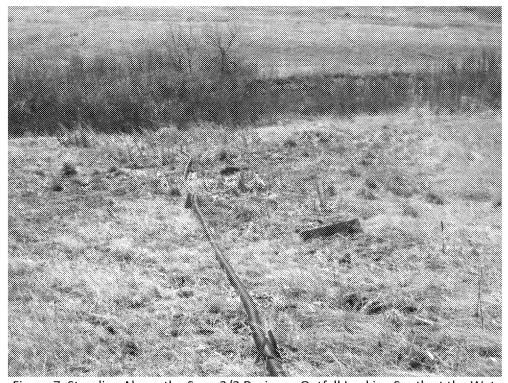
towards the EPC outfall. This water then continues to run south along the Seep 2/3 drainage pipe, creating pockets of water and damp soil running to Woman Creek (Figure 7). The Seep 2/3 drainage pipe was moved so that the drainage outfall would discharge in the EPC, in an effort to reduce the amount of water at the wet area. The wet area will be monitored to determine the effects of moving the Seep 2/3 drainage pipe, and to observe whether it is being fed by surface or subsurface sources. No ground movement has been observed in this area since the previous inspection. The rest of the historic seep locations on the OLF were dry at the time of inspection.

Figure 7. Standing Above the Seep 2/3 Drainage Outfall Looking South at the Wet Area Discovered
